Flood Control Project Maintenance
2014 Structure Summary Report
Overall Unit and Item Ratings

DWR Sutter Maintenance Yard

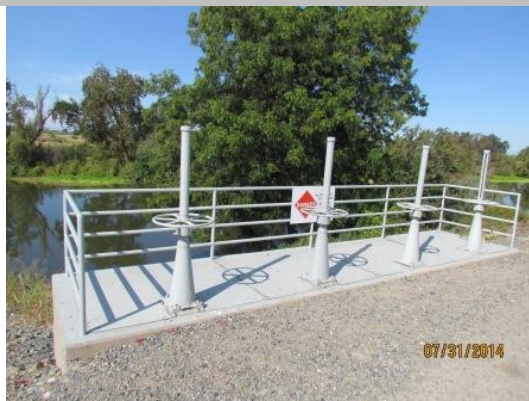
Photo 1 of 1 : ST_2014_NA0060_23_17_20140805_00018.jpg

LM Start	0.00	Rating **	A	Issue No.	17
LM End	0.00	Issue Type +	Ma	Location *	
Category	Pump Stations			GPS Latitude/Longitude	
				Start	End
Item	Manual Gate Operators			39.120096 °	39.120096 °
				-121.779230 °	-121.779230 °
DWR ID	DWR_NA0060_23_t_2012_17				
Action/Comments					
Inspector Comments: Manual gate operators appear to be in good working condition.

Photo shows manual gate operators.

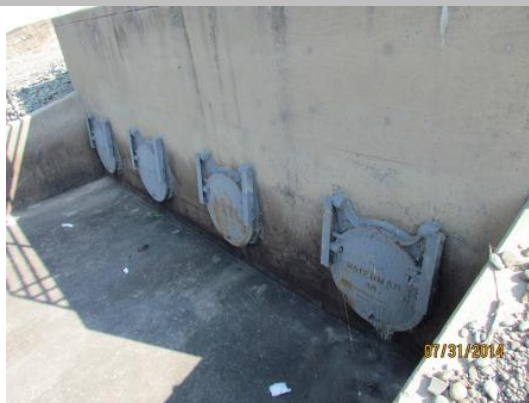
Photo 1 of 1 : ST_2014_NA0060_23_19_20140805_00019.jpg

LM Start	0.00	Rating **	A	Issue No.	19
LM End	0.00	Issue Type +	Ma	Location *	
Category	Pump Stations			GPS Latitude/Longitude	
				Start	End
Item	Flap Gates			39.120096 °	39.120096 °
				-121.779230 °	-121.779230 °
DWR ID	DWR_NA0060_23_t_2012_19				
Action/Comments					
Inspector Comments: Flap gates appear to be in proper working condition, they show no signs of corrosion or damage.

Photo shows flap gates and concrete outfall structure.

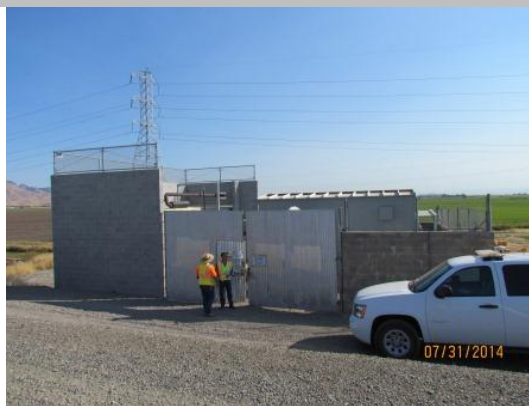
Photo 1 of 1 : ST_2014_NA0060_23_21_20140805_00020.jpg

LM Start	0.00	Rating **	A	Issue No.	21
LM End	0.00	Issue Type +	Ma	Location *	
Category	Pump Stations			GPS Latitude/Longitude	
				Start	End
Item	Security Fencing			39.120096 °	39.120096 °
				-121.779230 °	-121.779230 °
DWR ID	DWR_NA0060_23_t_2012_21				
Action/Comments					
Inspector Comments: Site is currently secured by a masonry brick wall.

Photo shows masonry brick wall which encloses the entire structure.

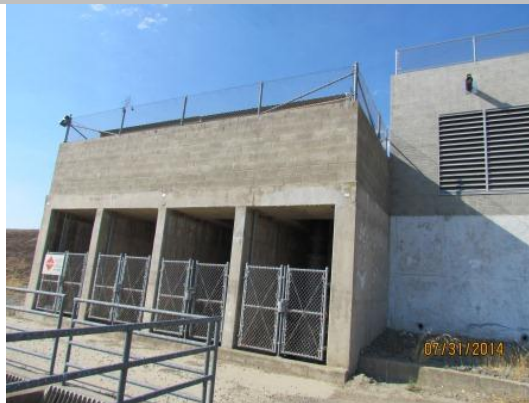
Photo 1 of 1 : ST_2014_NA0060_23_22_20140805_00021.jpg

LM Start	0.00	Rating **	A	Issue No.	22
LM End	0.00	Issue Type +	Ma	Location *	
Category	Pump Stations			GPS Latitude/Longitude	
				Start	End
Item	Intake and Discharge Pipes			39.120096 °	39.120096 °
				-121.779230 °	-121.779230 °
DWR ID	DWR_NA0060_23_t_2012_22				
Action/Comments					
Inspector Comments: No visible deficiencies observed in the pipe's condition.

View of the structure intake.

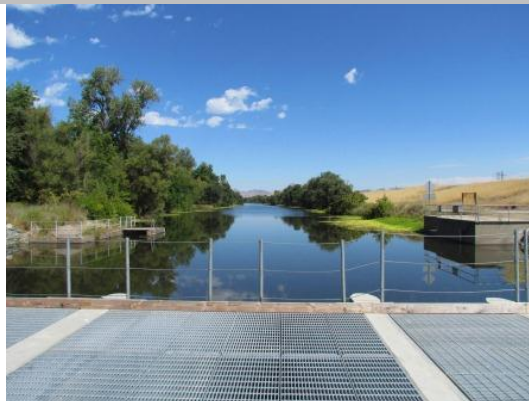
Photo 1 of 3 : ST_2014_NA0060_10_1_20140721_00004.jpg

LM Start	0.00	Rating **	N	Issue No.	1
LM End	0.00	Issue Type +	Ma	Location *	
Category	Structures & Concrete Lined Channels			GPS Latitude/Longitude	
				Start	End
Item	Photo Documentation			39.102763 °	39.102763 °
				-121.758738 °	-121.758738 °
DWR ID	DWR_NA0060_10_t_2012_1				
Action/Comments					
Inspector Comments: This weir is being replaced, the new weir is in the process of being built on the downstream side of weir number 2. Permit No. 18400 (CVFPB) issued 10-30-2008.

The view from upstream of the Sutter Bypass Weir #2.

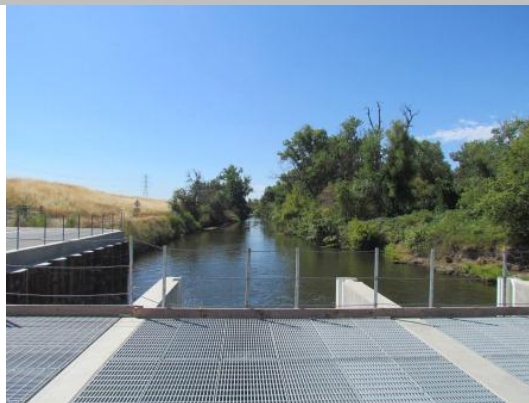
Photo 2 of 3 : ST_2014_NA0060_10_1_20140721_00005.jpg

The view from downstream of the Sutter Bypass Weir #2.

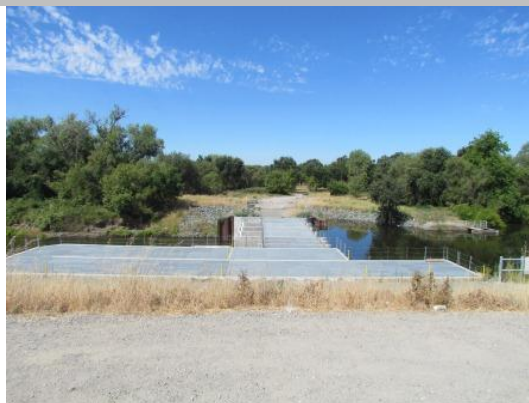
Photo 3 of 3 : ST_2014_NA0060_10_1_20140721_00006.jpg

This is a view of the Sutter Bypass Weir #2.

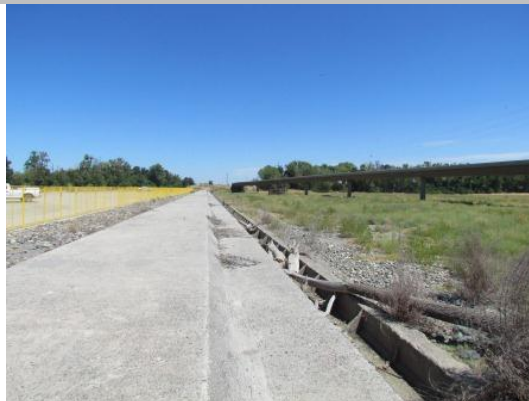
Photo 1 of 7 : ST_2014_NA0060_3_1_20140721_00011.jpg

This view is of the Tisdale Weir from the right bank levee.

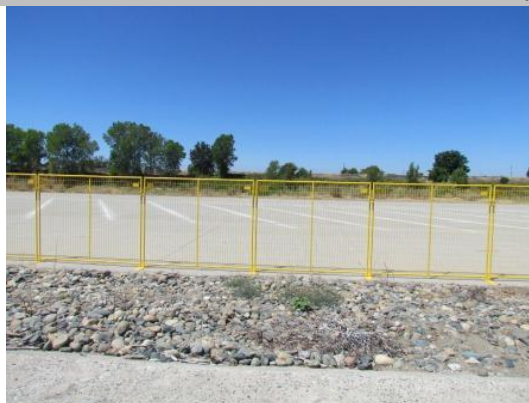
Photo 2 of 7 : ST_2014_NA0060_3_1_20140721_00012.jpg

The view upstream from the structure.

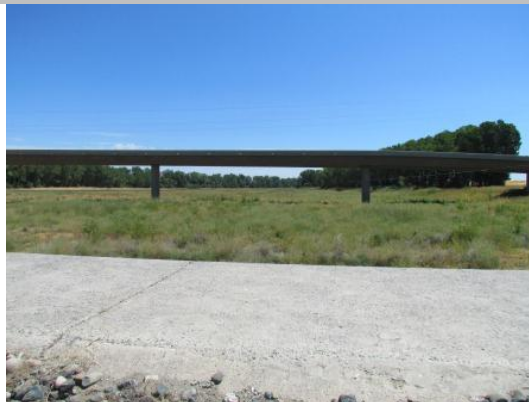
Photo 3 of 7 : ST_2014_NA0060_3_1_20140721_00013.jpg

The view downstream from the structure.

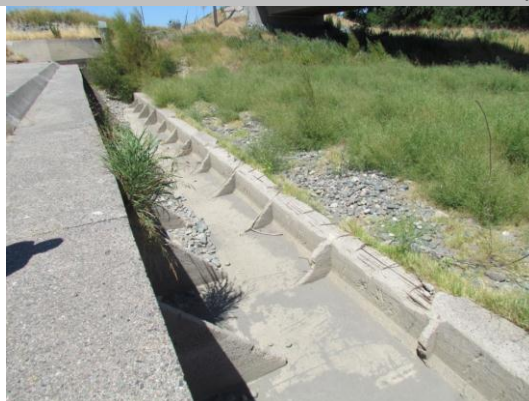
Photo 5 of 7 : ST_2014_NA0060_3_1_20140630_00005.jpg

Exposed rebar with lengths in excess of 6 feet. Should be cut off flush with concrete surface.

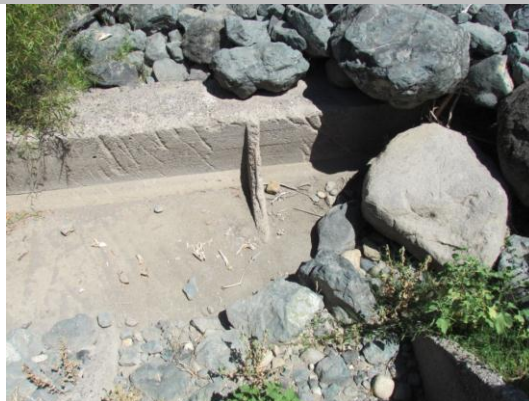
Photo 6 of 7 : ST_2014_NA0060_3_1_20140630_00003.jpg

Exposed rebar within the structure.

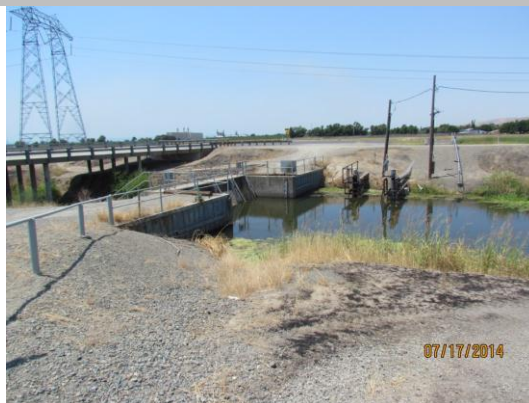
Photo 1 of 1 : ST_2014_NA0060_11_23_20140821_00004.jpg

LM Start	0.00	Rating **	N	Issue No.	23
LM End	0.00	Issue Type +	Ma	Location *	
Category	Structures & Concrete Lined Channels			GPS Latitude/Longitude	
				Start	End
Item	Photo Documentation			39.153325 °	39.153325 °
				-121.734122 °	-121.734122 °
DWR ID	DWR_NA0060_11_t_2012_23				
Action/Comments					
Inspector Comments: Upstream side of the structure is clear of debris.

View of the upstream side of the Wadsworth Canal Weir No. 4.
